### Canon 814E light meter manual malfunction repair . Manual iris function repair.

Canon 814 AUTO ZOOM ELECTRONIC(814E), I like this. A friend asked me for the repair because the manual iris was strange. The auto is Ok. The manual seems to move. However, it moves only to F8~11. And, it slowly returns to F4~5.6 when the hand is separated.

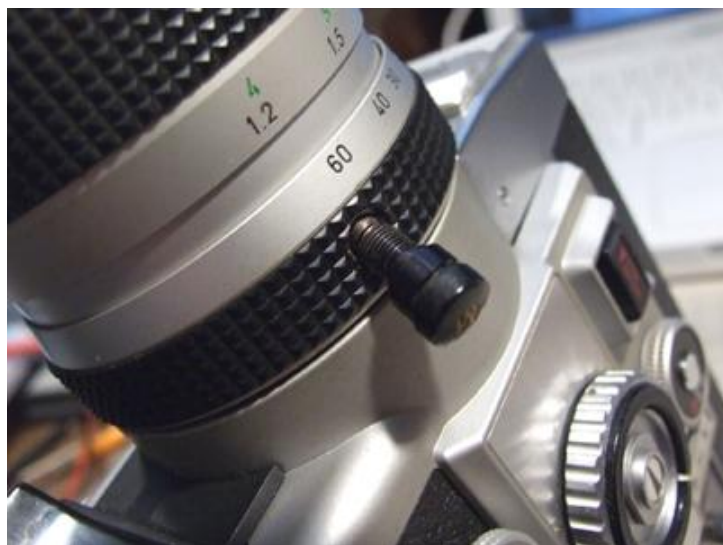
Canon 814 AUTO ZOOM ELECTRONIC, or 814E for short, is my favorite camera. I was asked if I could repair it because the aperture was strange, so I took it in. When I looked, the auto mode was working. It also works in manual mode. But it only goes to about F8~11. When I let go, it slowly returns to about F4~5.6. I had fixed a different problem before, but this was the first time I had seen this symptom. I don't really understand what's going on, but I opened it up anyway.

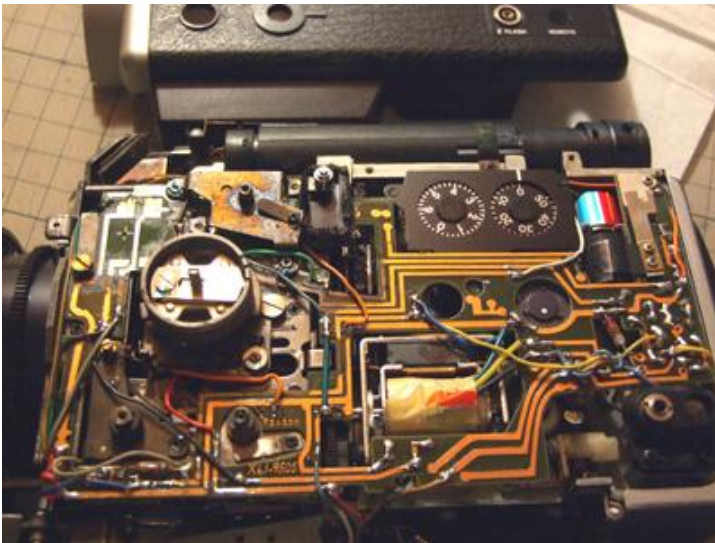
I tried moving it, but the symptoms did not change. What I found out was that if I pulled it tightly, I could move the aperture manually. Looking through the gap, it seemed like the dial was slipping when in manual mode.

The manual iris was Ok when making efforts and pulling it. The dial seems to slip when seeing from the space.

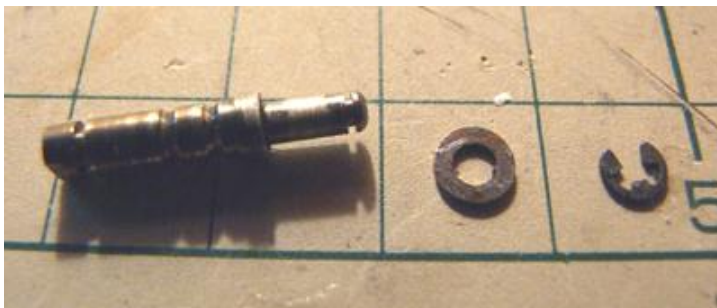
It's sticky.

It is a sticky paste.

Beautifully cleans it. I think about parts of taking the place

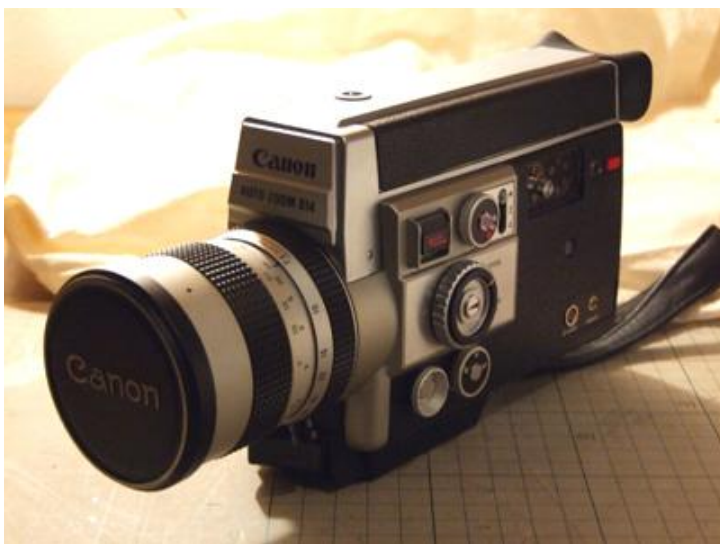
Finished! Perfect!

Reassemble. It is assembly . Because it is a nightmare when the screw is dropped, it is careful
